NOTCHY POWER STEERINGS, HOW TO SMOOTH THEM OVER

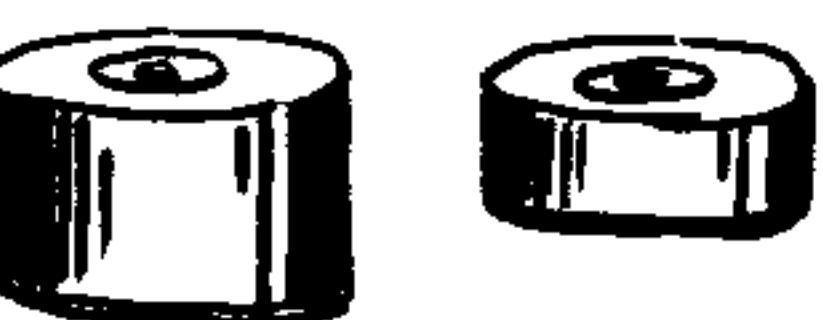
The steering is damped by dashpots situated below the spool valves, located within the casting wrapped up in a somewhat square boot or rubber dust cover. The same dashpots prevent the spool valves from opening too quickly, releasing pressure into the rack too brutally, ramming the rack's cylinder and possibly cracking it. They also prevent oscillations in the system, since they will correct errors in BOTH directions, unlike standard power steering units. The dashpots will correct errors in positions in the wheels caused by road irregularities and, of course, errors entered by a change only of the latter. As a matter of fact, the standard power steering units are only assisted power steerings, blindly helping along without knowing if the rack has reached the right position or not. The Citroen power steering is a Servo system, fully aware of what is going on at all times. The only trouble is that this is true when the dashpots let the valves open in time: let us say more than a few milliseconds and less than one second.

The dashpots are different before and after 1968. The old ones are about half as high as the new ones, that's all. Drop the pressure, remove the boot, unscrew the dashpots' covers, mark them right and left, they are matched to the pistons, keep the springs and remove the pistons. Remember what side they were on. Do not try to file them down, they are made of hard steel. Grind them down to what you want. Clean them and reassemble. If you do not have new O rings reuse the old ones after turning them upside down. Tighten the covers to 14 ft. lbs. The steering will have no more notch, however it might start twitching when you let go of the wheel, like the old ones did.

AFTER 1968 BEFORE 1968
DASH POTS
