NOTCHY POWER STEERINGS, HOW TO SMOOTH THEM OVER

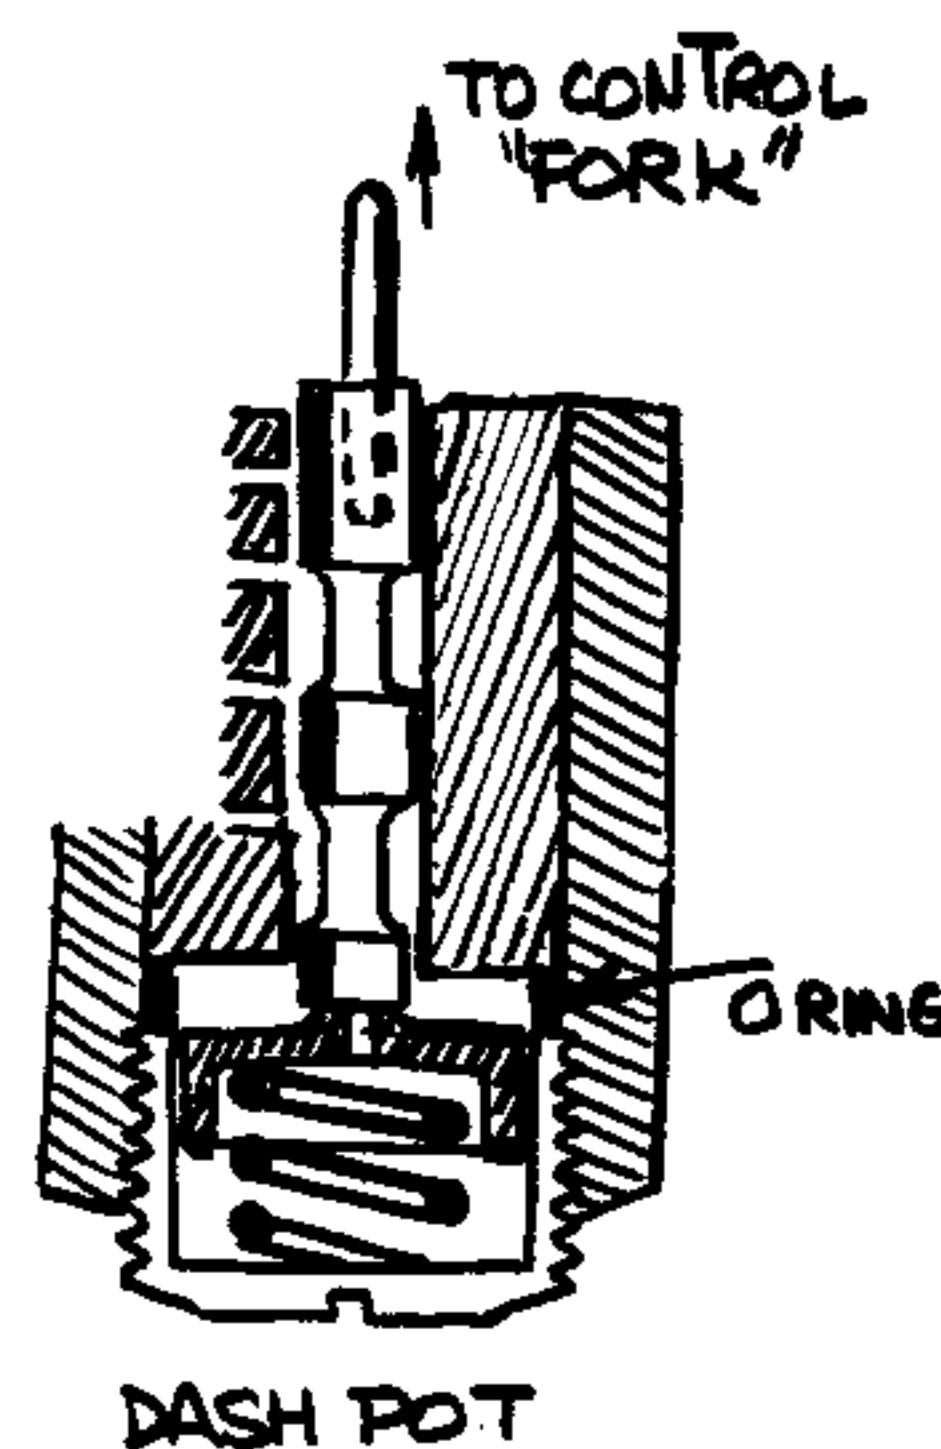
AFTER 1968 BEFORE 1968
DASH POTS

The dashpots are different before and after 1968. The old ones are about half as high as the new ones, that's all. Drop the pressure, remove the boot, unscrew the dashpots' covers, mark them right and left, they are matched to the pistons, keep the springs and remove the pistons. Remember what side they were on. Do not try to file them down, they are made of hard steel. Grind them down to what you want. Clean them and reassemble. If you do not have new O rings reuse the old ones after turning them upside down. Tighten the covers to 14 ft. lbs. The steering will have no more notch, however it might start twitching when you let go of the wheel, like the old ones did.
